RM No. E8F29

OPERATING TEMPERATURES OF I-40-5 TURBOJET ENGINE  
BURNER LINERS AND THE EFFECT OF TEMPERATURE  
VARIATION ON BURNER-LINER SERVICE LIFE

By H. D. Wilsted, Robert T. Duffy  
and Ralph E. Grey

August 23, 1948

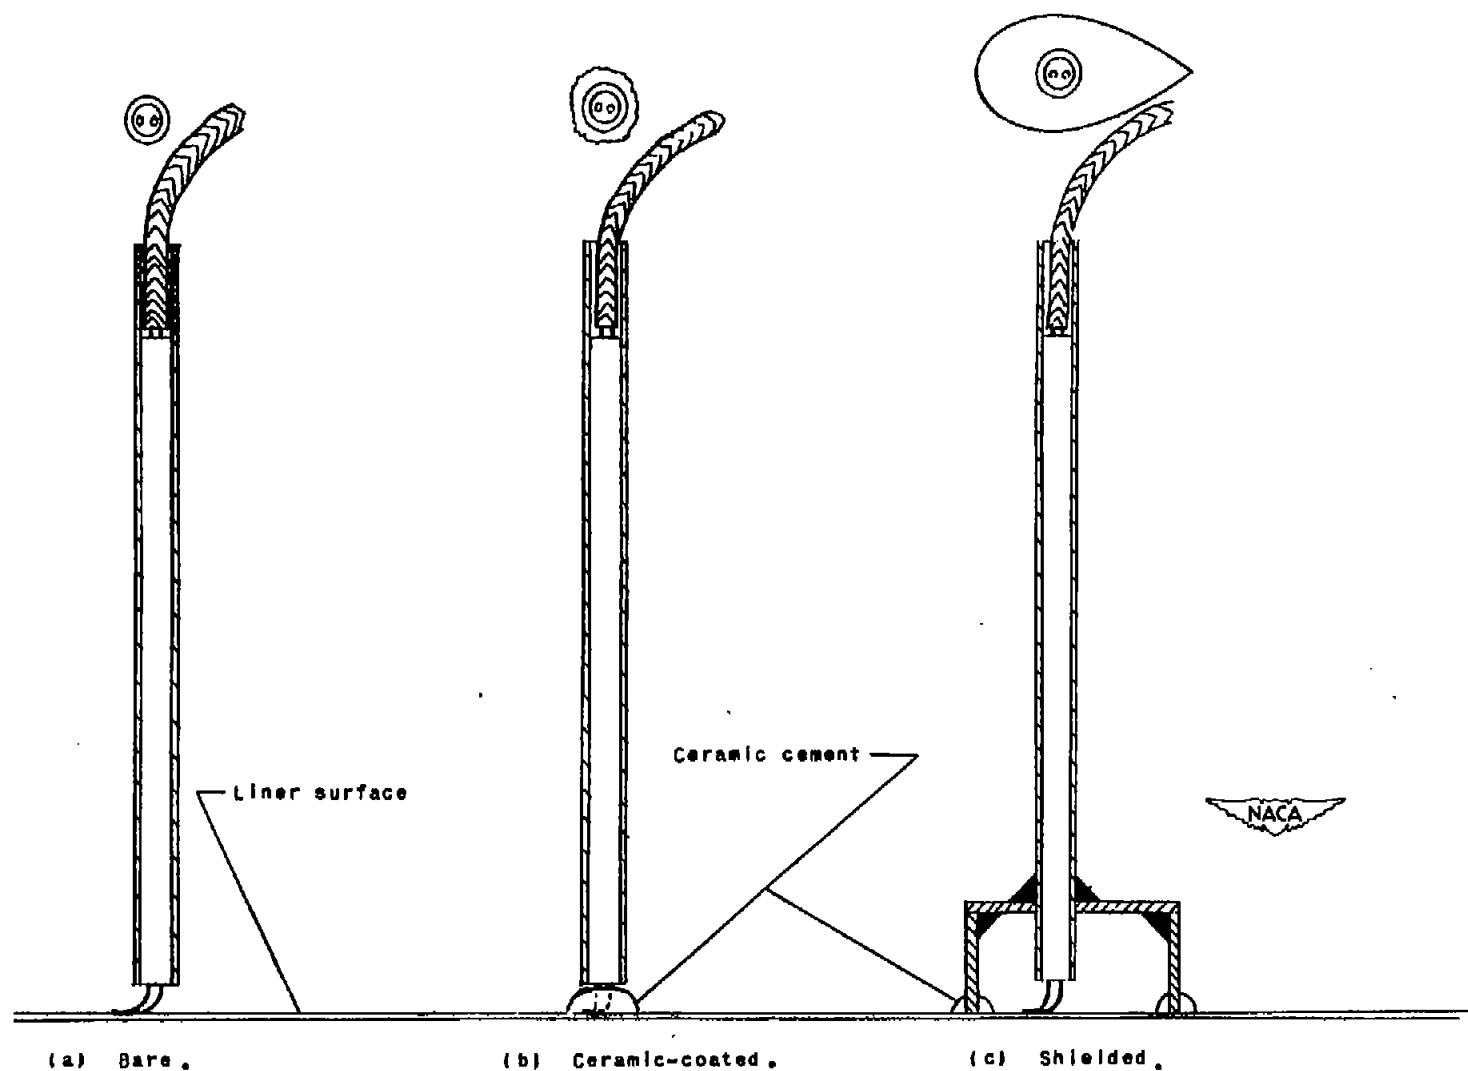
Figure 3. - Thermocouple installations used to determine most correct method of measuring burner-liner temperatures. Thermocouple wires spot-welded to liner.

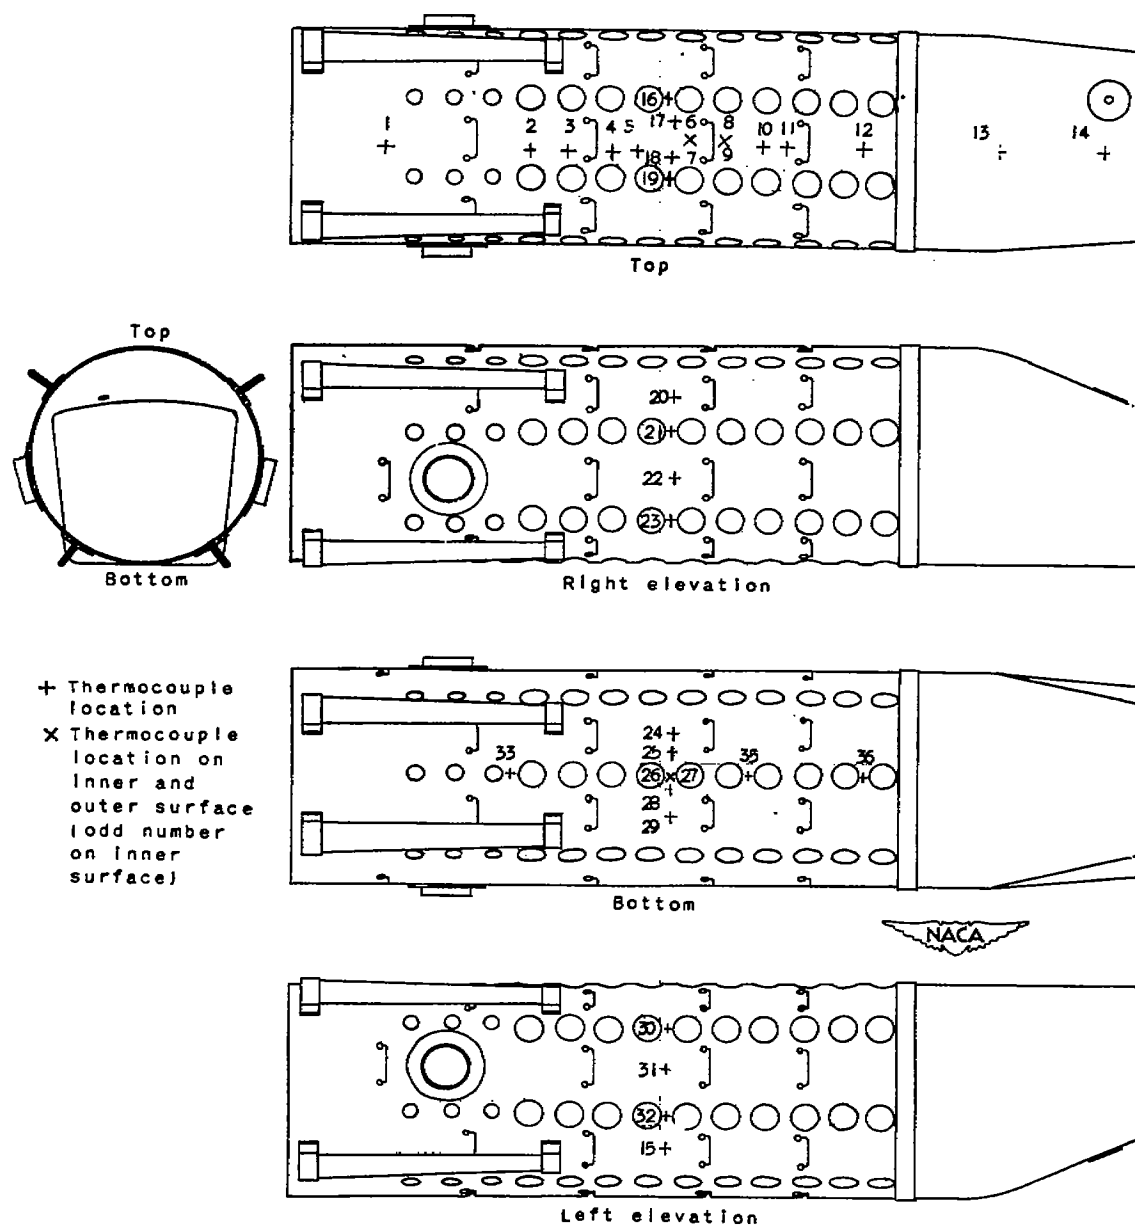
The thermocouple locations on the first burner liner investigated (designated liner A) are shown in figure 6. The results of the investigations of liner A over a complete range of engine speed are shown in figures 7, 8, and 9. Figure 7 shows the temperature variation along the top row of cooling louvers. At maximum engine speed a variation of the order of 600° F in a length of 3 inches is shown. The maximum indicated temperature along the row of louvers is of the order of 1300° F.

Figure 6. - Thermocouple locations and numbers on burner liner A.

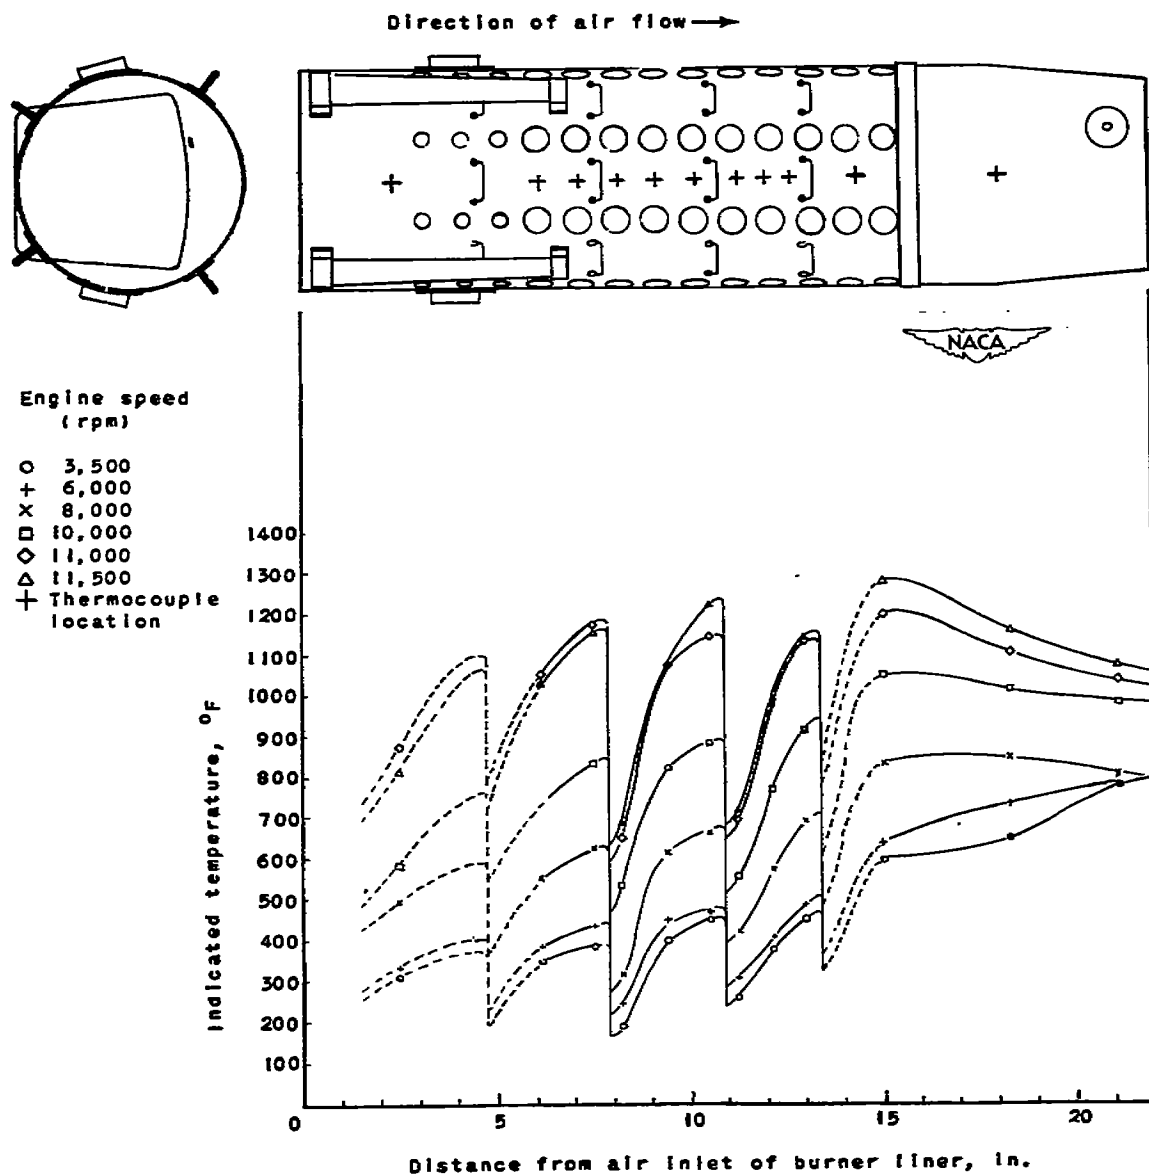
Figure 7. - Temperature variation along top row of cooling louvers on burner liner A at various engine speeds.

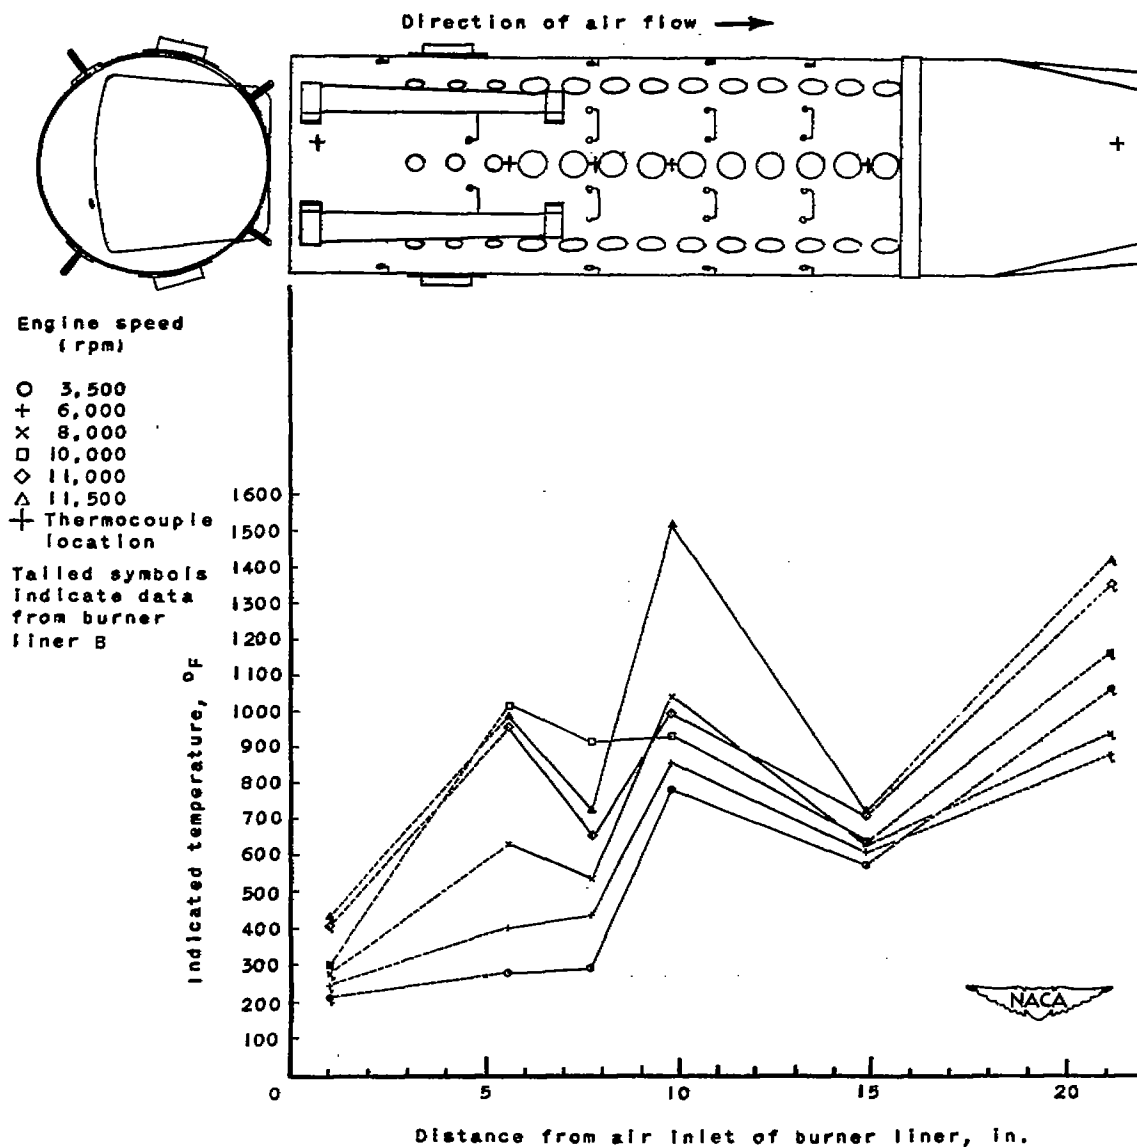
The temperature variation along the center line of a section containing air-intake holes is shown in figure 8. This section is on the bottom of the liner, as shown in figure 6. With one exception, the maximum indicated temperature was only of the order of 1000° F if the noncritical liner-exit section is not considered. As can be seen from figure 9, these values are probably peculiar to the particular sections and no general conclusions comparing the louver and air-intake sections can be drawn. The wide circumferential temperature variations shown in figure 9 indicate no definite trend. An irregularity exists, however, in the pattern with the highest temperature region located at the lowest portion of the burner liner as installed in burner 12.

Figure 8. - Temperature variation along bottom row of air intake holes on burner liner A at various engine speeds.

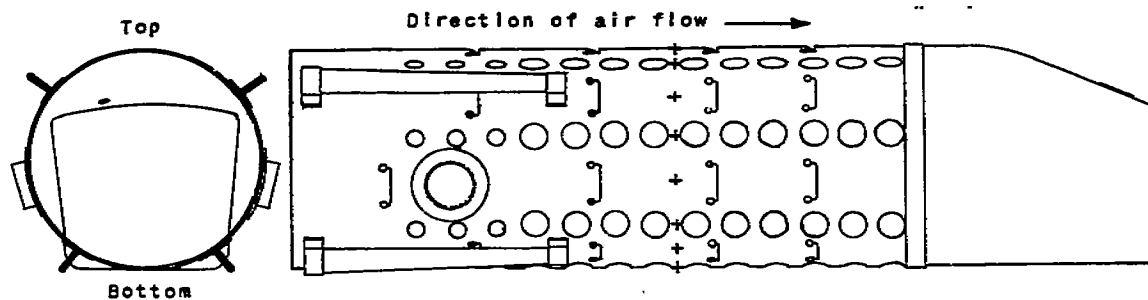
sections containing the louvers and air-intake holes, respectively. An examination of the data shows that the highest indicated burner-liner temperature recorded in these investigations was 1590° F, as shown in figure 9 at an engine speed of 11,500 rpm. This peak temperature occurred in the thermocouple belt  $9\frac{1}{2}$  inches from the inlet end of the liner near the critical section.

Temperature gradients as great as 700° F per inch of circumference are shown in figure 9 (point A). The high-temperature gradients from point to point in the burner liner are probably the cause of failure, the principal factor at the present time limiting the service life of the gas-turbine engine. Any process or method that will remove heat from the hot spots or give a more even temperature distribution such as the use of heavier gage metal for the liners to more rapidly conduct heat away from the hot spots or the use of cooling fins to remove heat from the high temperature areas should add materially to the burner-liner service life.

Figure 9. - Circumferential burner-liner temperature distribution near hottest temperature belt on burner liner A at various engine speeds. Average diameter of liner, 5.5 inches. (Dashed lines indicate missing temperature readings as a result of thermocouple failure.)

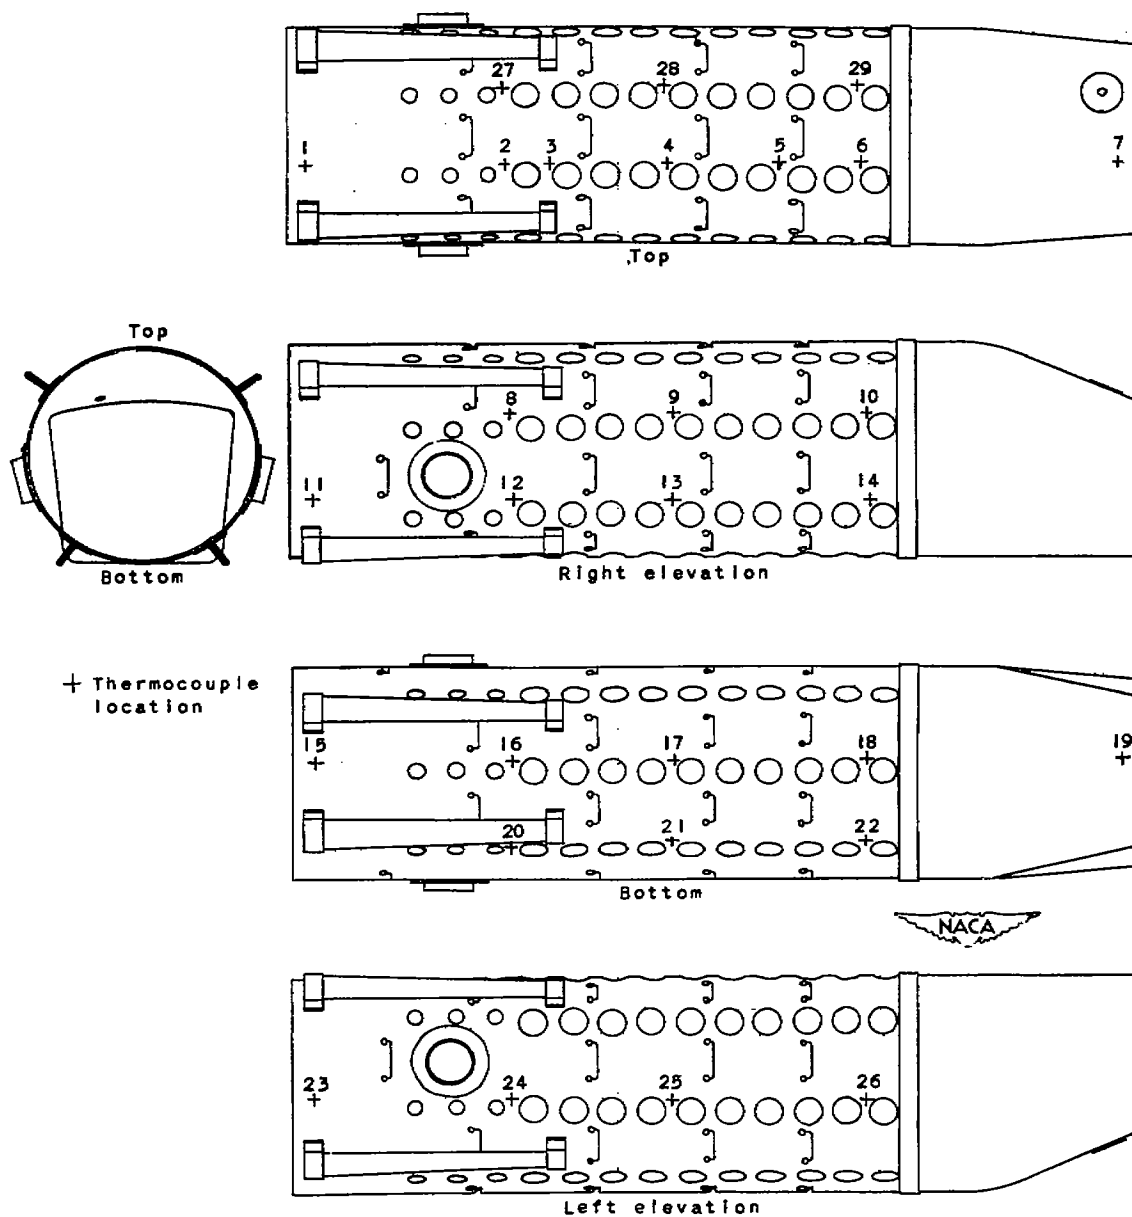
The thermocouple locations on burner liner B are shown in figure 10. In this case, it was felt that temperatures taken between the rows of holes and louvers would be more indicative of the effective liner temperature because less variation would result from cooling effects of the incoming air.

Figure 10. - Thermocouple locations and numbers on burner liner B.

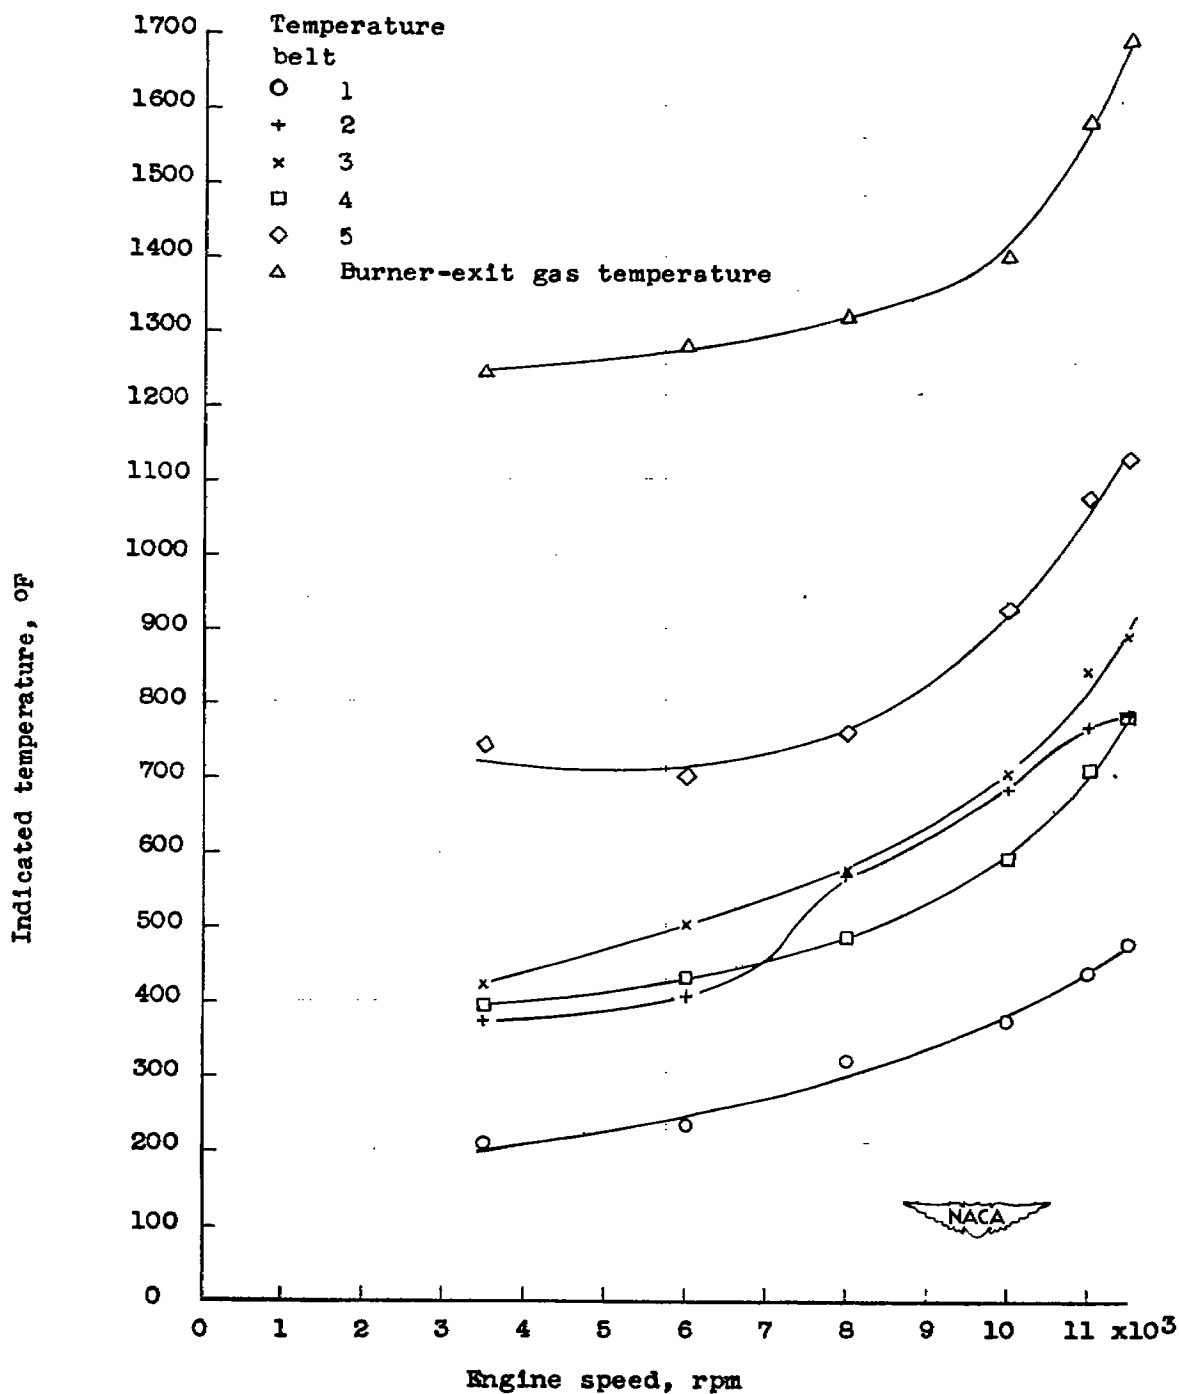
A replot of the data used in figure 11 is presented for each temperature belt in figure 12 to show the temperature variations with speed. The trend of rising burner-liner temperature with increasing speed or power in figure 12 is reasonably uniform. The irregularity of temperature belt 2 is attributed to the disturbance of the interconnector fittings on air flow. Also shown is the indicated burner-exit gas temperature, which reached a maximum of 1690° F at an engine speed of 11,500 rpm. In general, all the curves are reasonably smooth with temperatures rising at an increasing rate with engine speed.

Figure 12.- Temperature variation with engine speed of temperature belts on burner liner B. All points are average belt temperatures. (See fig. 11 for belt location.)

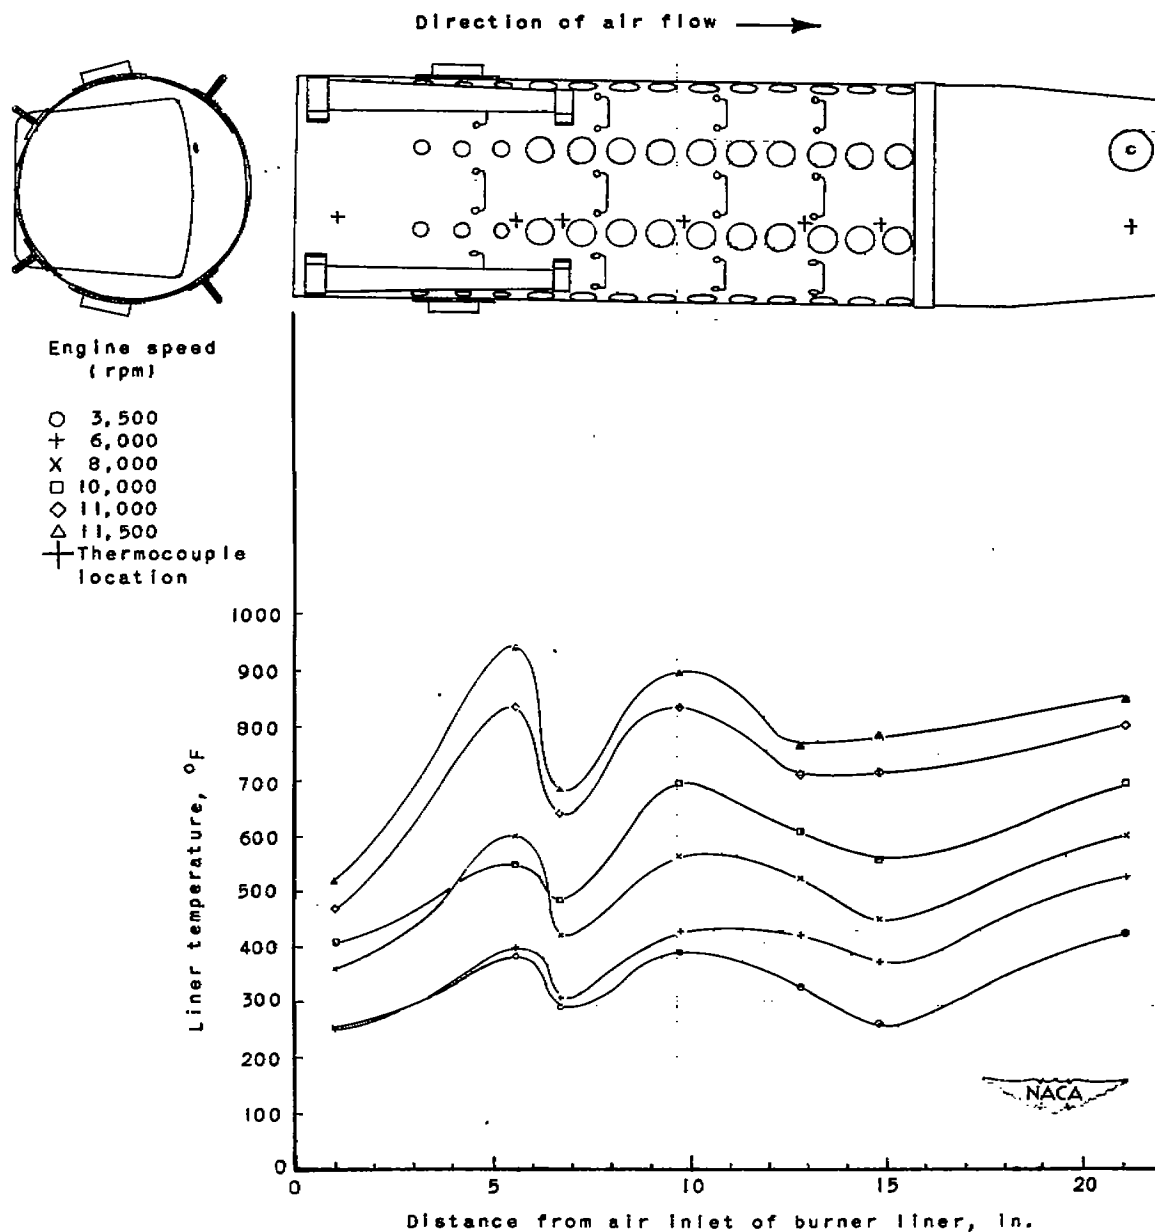
The temperature variations along the top of burner liner B, between the louvers and air-intake holes, are shown in figure 16. Except for the rapid variation in temperature at the section between the series of small and large air-intake holes, a relatively small temperature variation exists as contrasted by the variations in figures 7 and 8 for the axial distribution along the center line of the

Figure 16. - Temperature variation along top of burner liner B at various engine speeds.
